## Leamington Spa, Warwickshire

## Insurance Assessment Project Value | £500

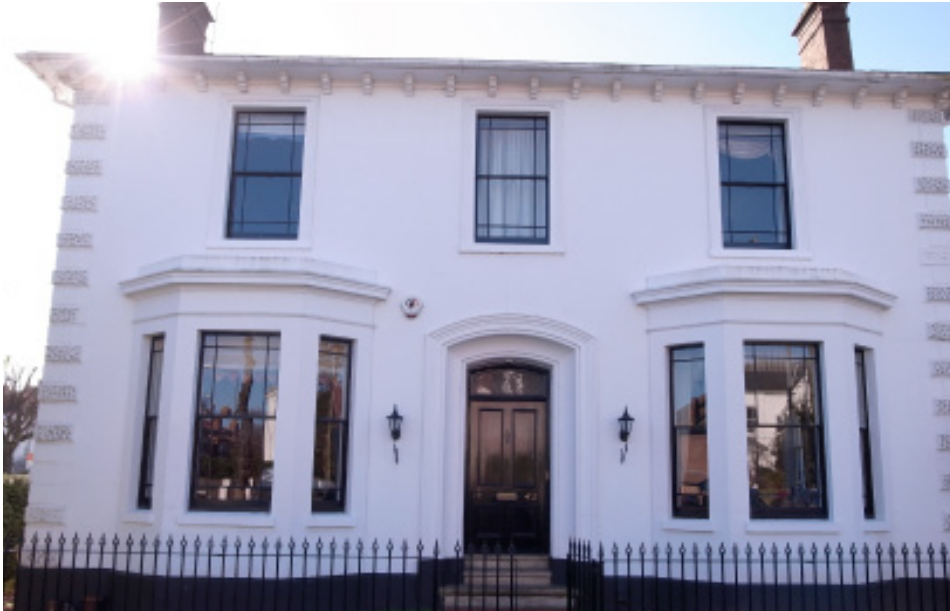
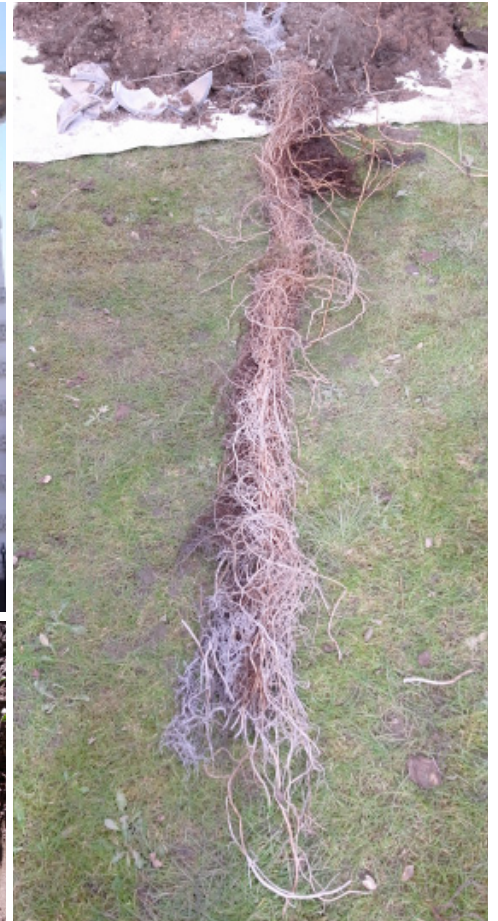
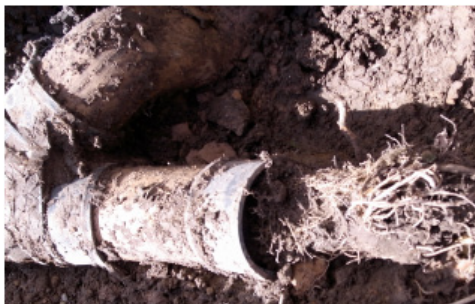
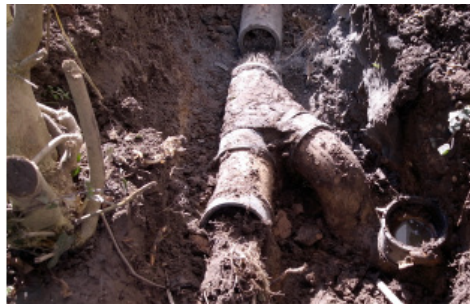
Using CCTV electro location and other survey techniques we were able to isolate the problem area and identify the drainage runs which roots had affected. This has caused the surface water sewers to flood overland and into the basement causing thousands of pounds worth of damage.

Using all the data gathered from the survey, design options were presented to ensure the drainage system was repaired to the most cost effective solution.

**RMC Water** ensured all regulations were met and the new system was installed in a short time frame to ensure the risk of reoccurring flooding to the property was reduced.

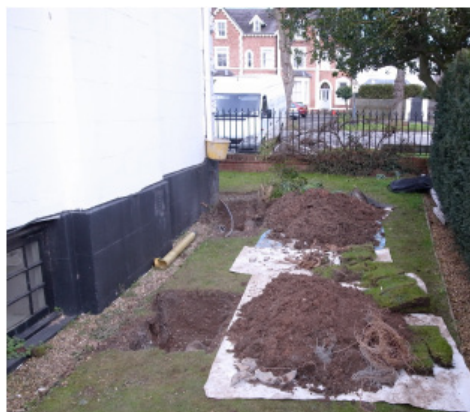
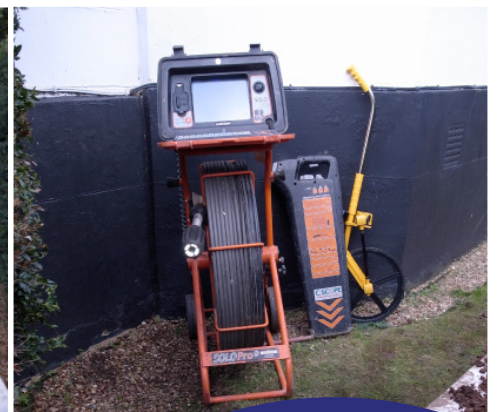
**RMC Water** ensured all regulations were met and the new system was installed in a short time frame
